Federal Chamber of Automotive Industries

# New Vehicle Receiving & Inspection Procedures

Effective May 2014

Revision 16.05.2014 (V.8)

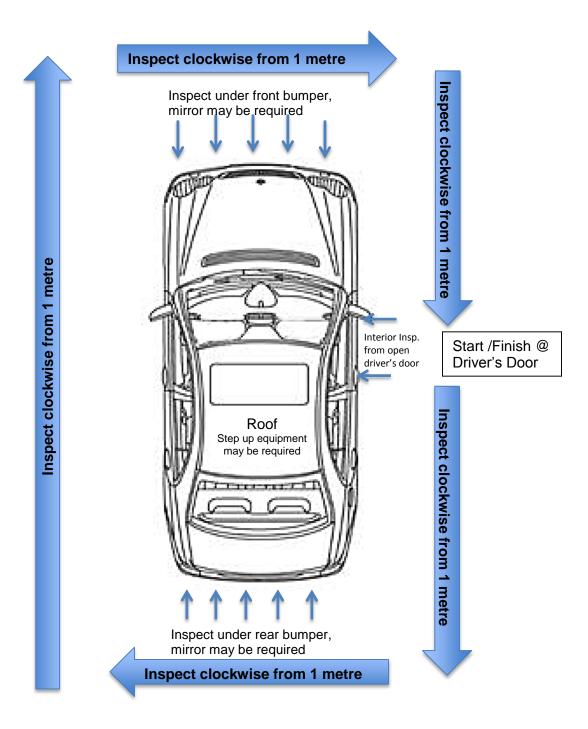
#### **Inspection Process Diagram A**

Survey to be conducted from a distance of one (1) metre proceeding in a clockwise direction.

8.1.3 The inspection of the vehicle(s) is to take place at a distance of **one (1) metre**. Minor scratches and scuffs that cannot be seen from a distance of **one (1) metre** are not be accepted as transit damage. Adequate step up equipment is to be used to safely inspect high panel roofs. Inspection includes under bumper examination by use of either mirrors or hand.

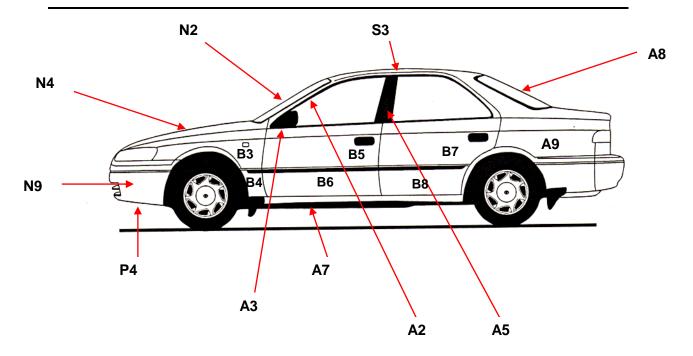
- A2 PILLAR W/SHIELD LEFT FRONT
- A3 MIRROR OUTSIDE LEFT
- A5 PILLAR LEFT CENTRE
- A7 ROCKER PANEL LEFT
- A8 EXTENSION ROOF LEFT REAR
- A9 QUARTER PANEL LEFT
- B3 FENDER LEFT FRONT DOOR, UPPER
- B4 FENDER LEFT FRONT DOOR, LOWER
- B5 DOOR LEFT FRONT, UPPER
- B6 DOOR LEFT FRONT, LOWER
- B7 DOOR LEFT REAR, UPPER
- B8 DOOR LEFT REAR, LOWER
- P4 AIR DAM (SKIRT)
- N2 WINDSHIELD
- N4 BONNET
- N5 HEADER PANEL/HOOD EXTENSION
- N9 BUMPER COVER FRONT
- S3 ROOF

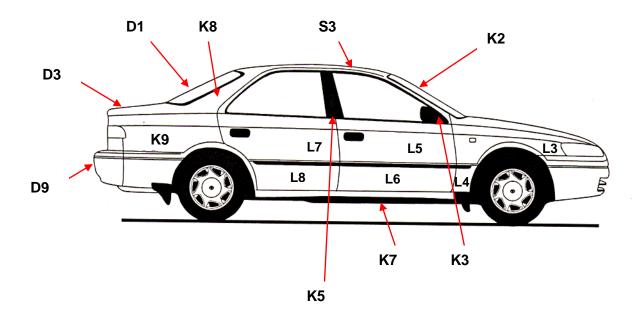
- D1 GLASS REAR
- D3 BOOT LID/TAILGATE/HATCHBACK
- D9 BUMPER/COVER REAR
- K2 PILLAR W/SHIELD RIGHT FRONT
- K3 MIRROR OUTSIDE RIGHT
- K5 PILLAR RIGHT CENTRE
- K7 ROCKER PANEL RIGHT
- K8 EXTENSION ROOF RIGHT
- K9 QUARTER PANEL RIGHT
- L3 FENDER RIGHT FRONT, UPPER
- L4 FENDER LEFT FRONT, LOWER
- L5 DOOR RIGHT FRONT, UPPER
- L6 DOOR RIGHT FRONT, LOWER
- L7 DOOR RIGHT REAR, UPPER
- L8 DOOR RIGHT REAR, LOWER
- S3 ROOF PANEL (TURRET) REAR

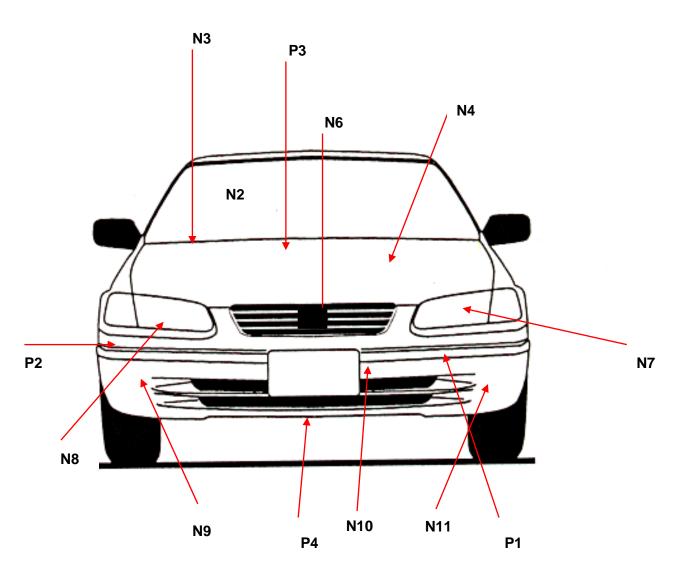
- P1 BUMPER/GUARD/STRIP FRONT
- P2 PANEL BEHIND BUMPER FRONT
- P3 COWL, VENT PANEL
- P4 AIRDAM (SKIRT)
- N2 GLASS WINDSHIELD
- N3 WIPERS
- N4 BONNET
- N6 GRILLE
- N7 HEADLAMP/RIM LEFT
- N8 HEADLAMP/RIM RIGHT
- N9 BUMPER COVER LEFT
- N10 BUMPER COVER MIDDLE
- N11 BUMPER COVER RIGHT

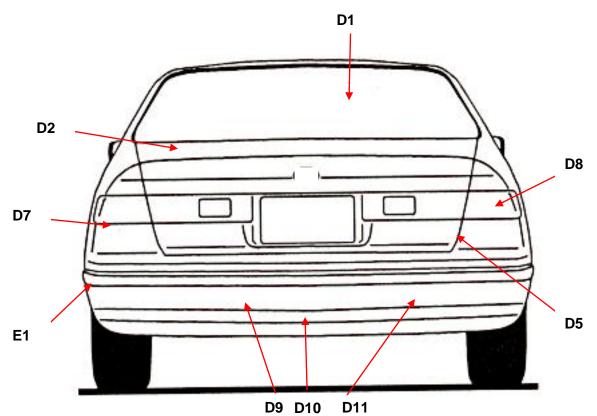
- E1 BUMPER GUARD/STRIP REAR
- D1 GLASS REAR
- D2 PANEL REAR COMP FRONT
- D5 END PANEL REAR
- D7 TAIL LAMP/RIM LEFT
- D8 TAIL LAMP/RIM RIGHT
- D9 BUMPER/COVER LEFT
- D10 BUMPER/COVER MIDDLE
- D11 BUMPER/COVER RIGHT

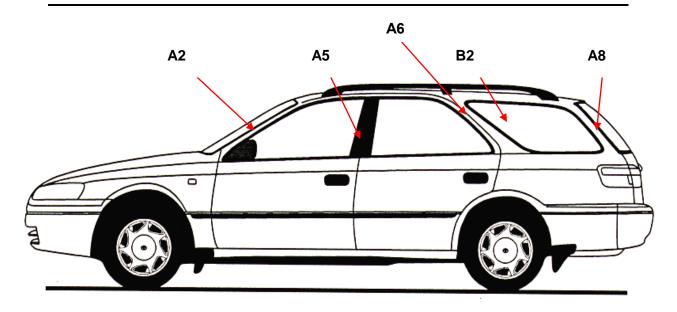
- A2 PILLAR W/SHIELD, LEFT FRONT
- A5 PILLAR LEFT CENTRE
- A6 PILLAR REAR
- A8 EXTENSION ROOF LEFT REAR
- B2 WAGON LEFT SIDE WINDOW

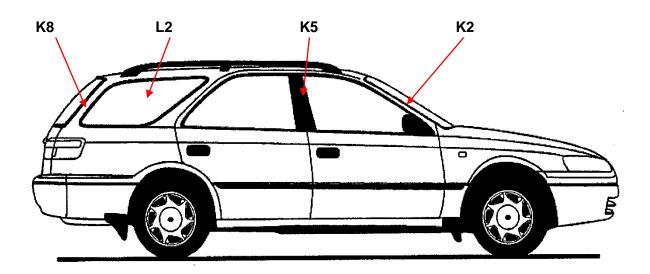
- K2 PILLAR W/SHIELD, LEFT FRONT
- K5 PILLAR LEFT CENTRE
- K8 EXTENSION ROOF LEFT REAR
- K2 WAGON LEFT SIDE WINDOW
